Manhole Inspection Summary

Manhole # S21C__028MH

Insp Date: **10/17/07 11:23 AM**

Location Address: **501 MONROE ST**

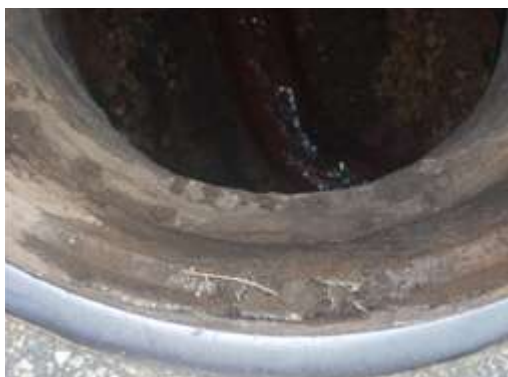
Defect 4

Frame Offset: **1** (in.) Condition: ☒ Sound ☐ Cracked ☐ Leaks

FRAME OFFSET

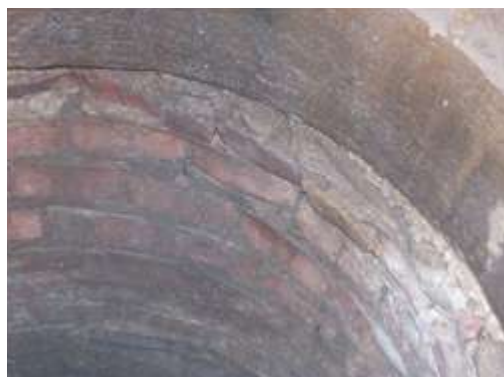
Defect 3

Chimney / Frame Adjustment ☒ Exists Material: **Brick** ☐ Parged Height: **3** (in.)

Condition: ☐ Sound ☐ Cracked ☐ Root Intrusion ☐ Loose Brick ☒ **Deteriorated**

DETERIORATED CHIMNEY

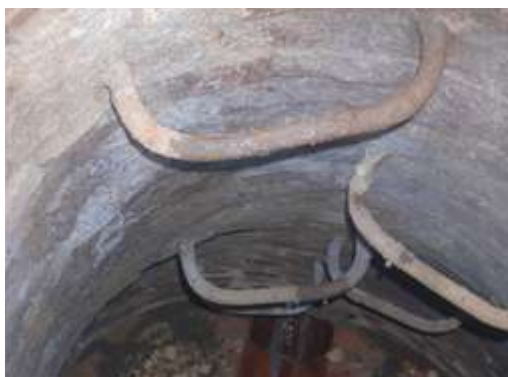
Defect 2

Steps Count: **5** Missing: **0** ☐ Corroded

CORRODED STEPS

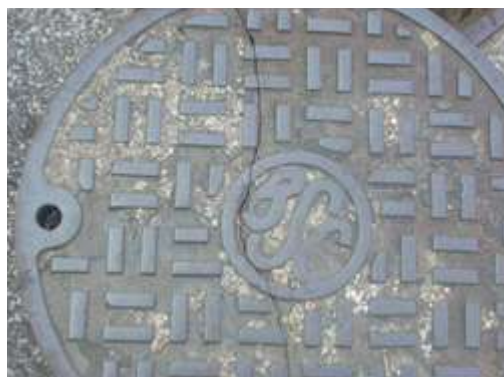
Defect 1

Type: **Sanitary** Condition: **Cracked** Cover Material: **Cast Iron**

CRACKED LID

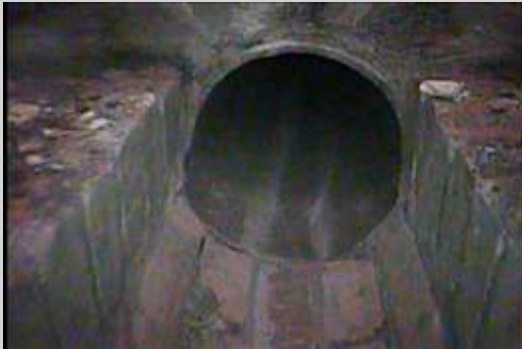
12 O'Clock Outflow

8 in. Circular Gravity Sewer
Pipe Out @ 12 O'Clock

Pipe Height: **8.4** (in.) Rod and Bar (Angled)
Pipe Material: **Clay** ☐ Pipe Lined
Invert Depth: **8.42** (ft.) Flow Characteristics: **Slow**
Deposits: ☒ None ☐ Mud ☐ Sludge ☐ Debris ☐ Grease
Silt Depth: (in.) Deposits Extent:
Infiltration: **None** Pipe Seal Cond: **Sound**

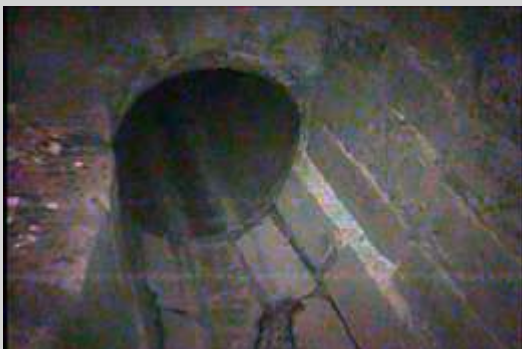
3 O'Clock Inflow

8 in. Circular Gravity Sewer
Pipe In @ 3 O'Clock

Pipe Height: **8.4** (in.) Rod and Bar (Angled)
Pipe Material: **Clay** ☐ Pipe Lined
Invert Depth: **8.21** (ft.) Flow Characteristics: **Slow**
Deposits: ☒ None ☐ Mud ☐ Sludge ☐ Debris ☐ Grease
Silt Depth: (in.) Deposits Extent:
Infiltration: **None** Pipe Seal Cond: **Sound**
